MERRIMACK RIVER BASIN  
WENTWORTH, NEW HAMPSHIRE

**BAKER FLOODWATER RESERVOIR  
SITE 11  
NH 00478**

**PHASE I INSPECTION REPORT  
NATIONAL DAM INSPECTION PROGRAM**

**JULY 1979**

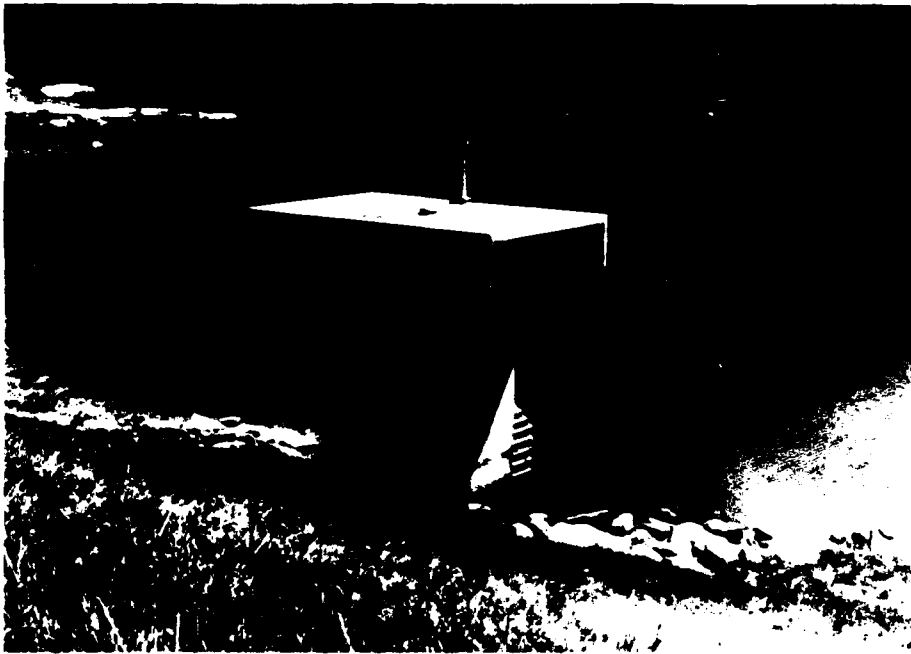
PHOTO NO. 5 - View of riser from dam.

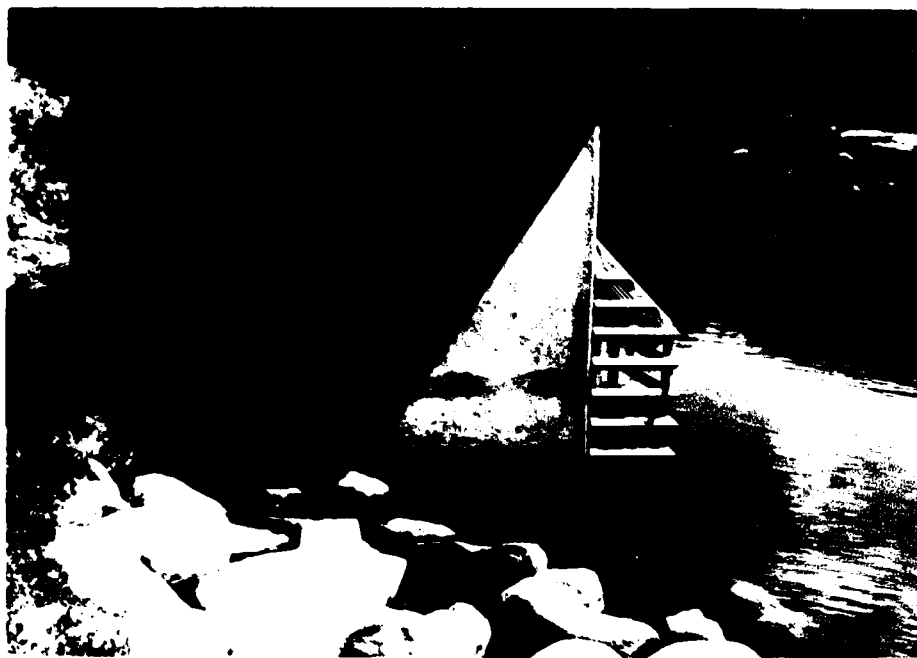
The concrete surface of the riser structure generally appeared to be in good condition except for concrete water staining and some surface scaling see (Photo No. 7). The spillway trash racks are also in good condition; no rust or peeling of the protective coating was noted.

The principal spillway structure consists of three elements, an overflow control with low stage inlet and high stage spillway crest, a vertical transition and a closed discharge conduit. The riser structure is placed in the embankment. Visual inspection revealed that the riser structure appeared to be in good condition except for some surface mortar loss and water staining, see Photo No. 7.

PHOTO NO. 7 - View of left side of riser.

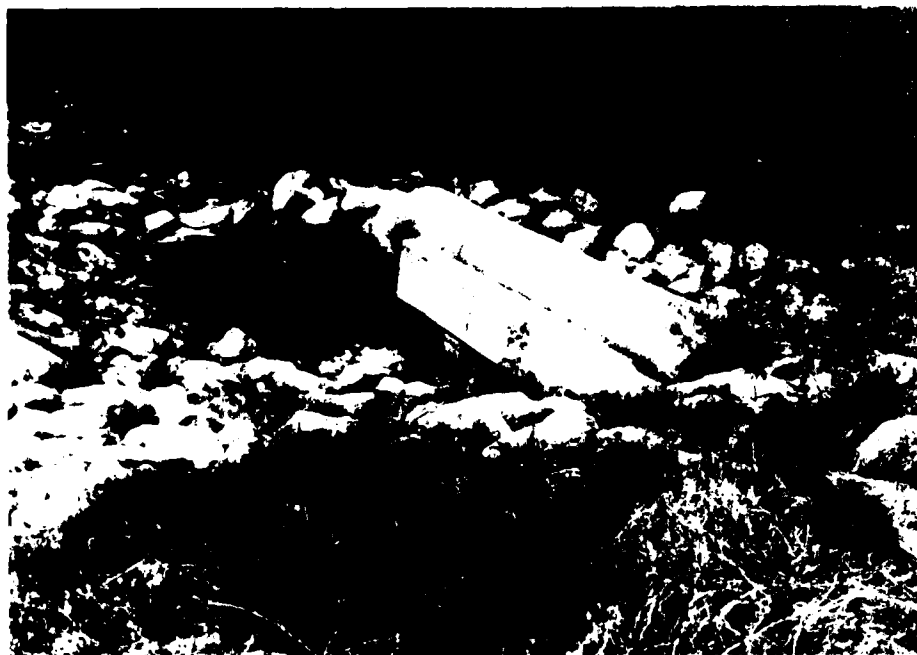
PHOTO NO. 11 - View of discharge area of emergency spillway.

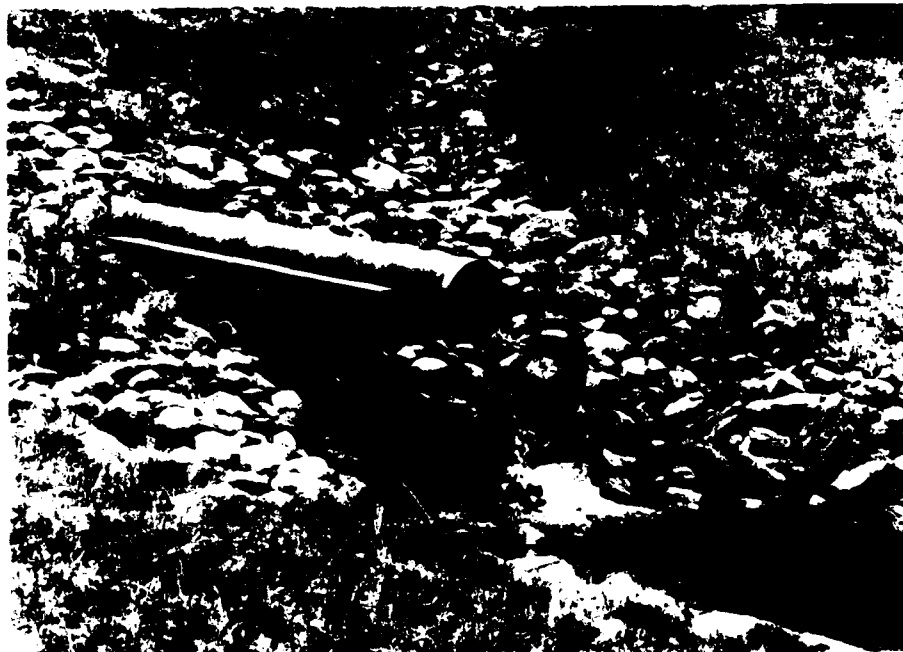
The 30 inch reinforced concrete discharge pipe, concrete cradle and supporting pier at the toe of the dam are in good condition as seen in Photos No. 12 & 13.

PHOTO NO. 13 - View of principal spillway outlet and portion of plunge pool.
